**National Highway
Traffic Safety
Administration**

Case Vehicle (A): 2000 Ford
Type: Expedition Eddie Bauer 4 x 4, 4-door SUV
Driver: 50-year-old female
CDC: 12-FRLE-3

Vehicle (B): 1989 Ford
Type: Taurus LX, 4-door sedan
Driver: 33-year-old female
CDC: 99-0000-0

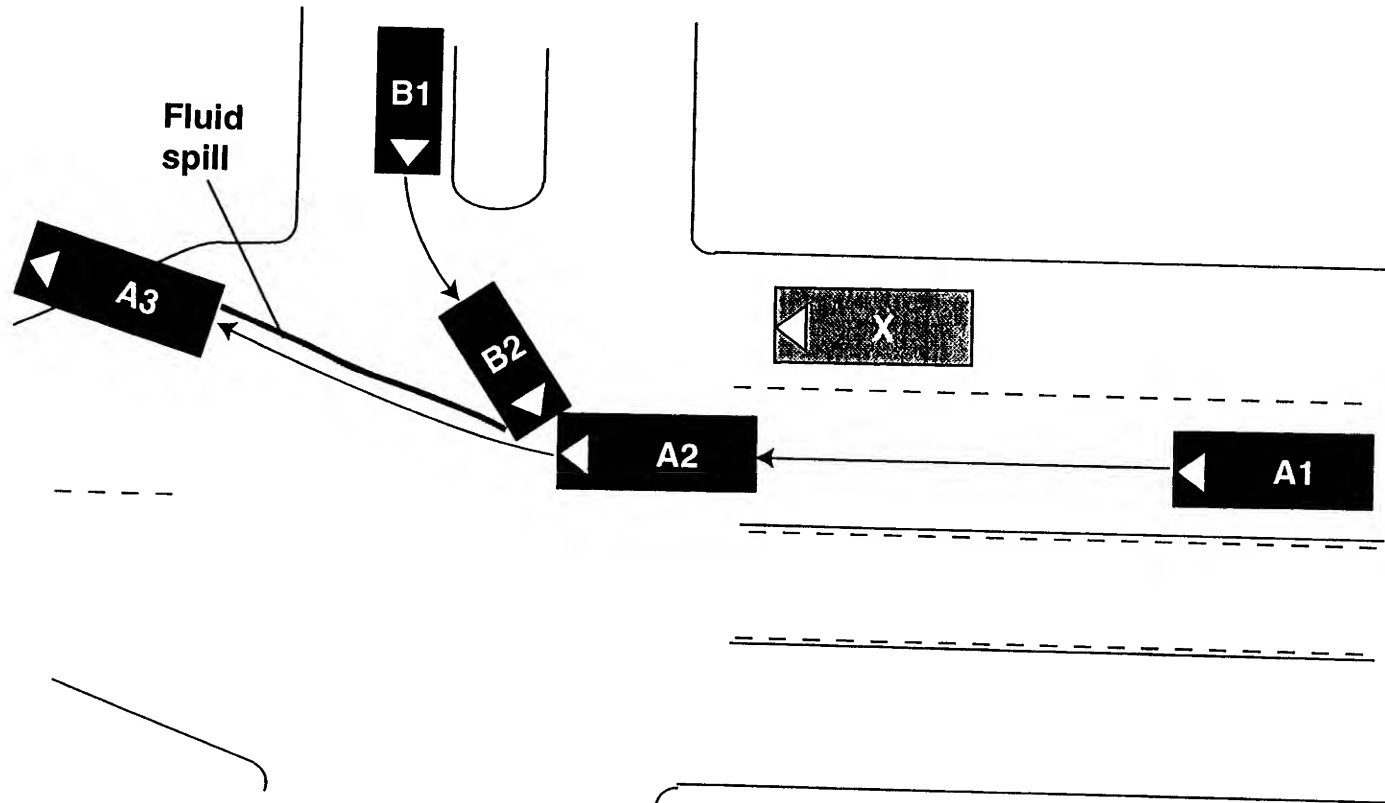
ACCIDENT SCHEMATIC

ACCIDENT DESCRIPTION: Case vehicle (A) WAS TRAVELING WEST
ON A 4-LANE ASPHALT ROAD. Vehicle (B) WAS EXITING
A PARKING LOT, AND WENT INTO THE PATH OF CASE
VEHICLE (A). The right-front of case vehicle (A)
CONTACTED THE LEFT-FRONT OF
VEHICLE (B). Case vehicle (A) PROCEEDED TO OVERRIDE
THE FRONT OF VEHICLE (B)

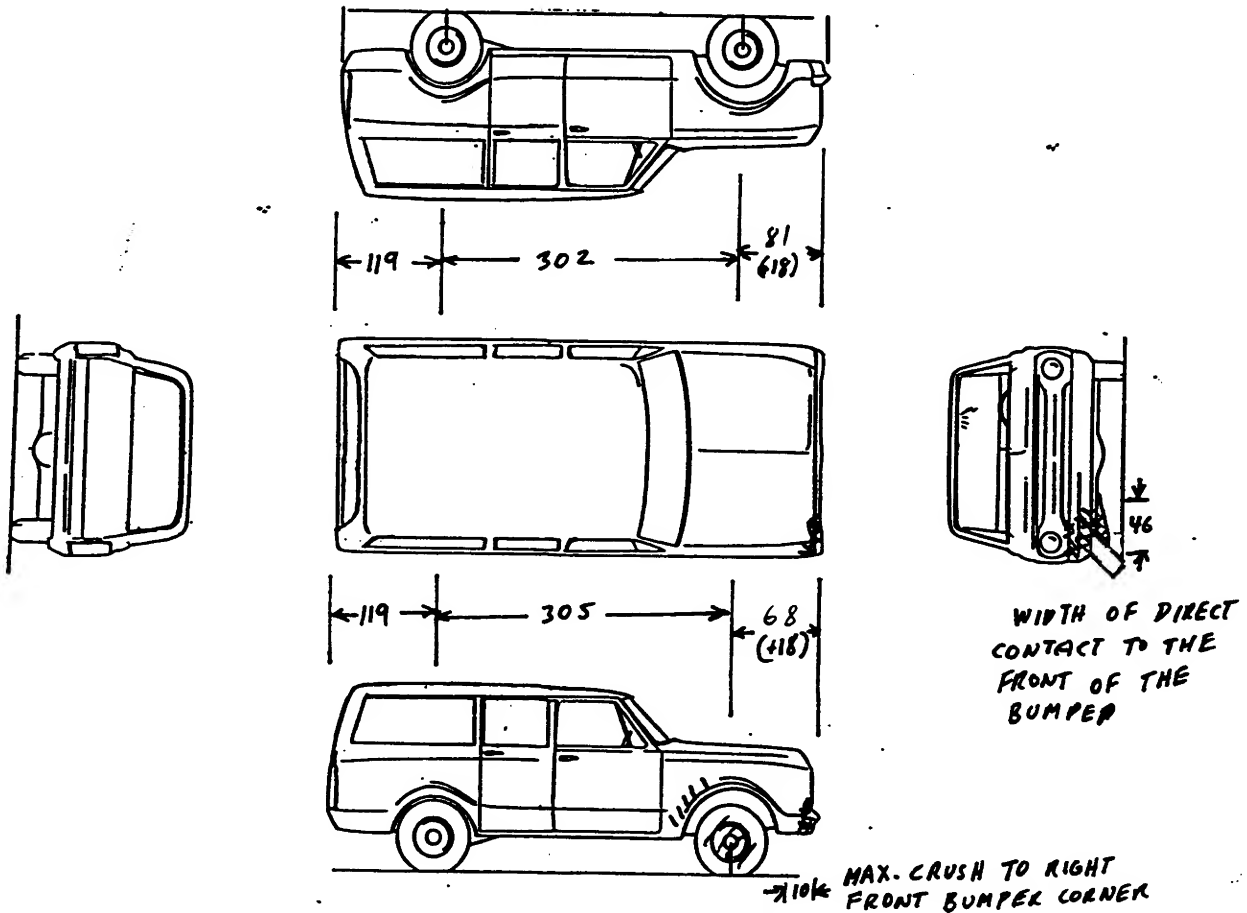
VEHICLE DAMAGE

Direct Damage Length (DDL) 046 cm
35 37

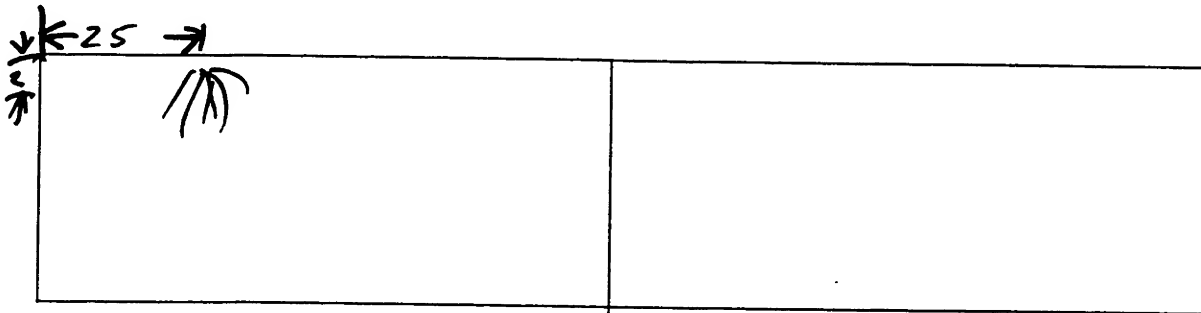
CONTACT BY
LT HAND

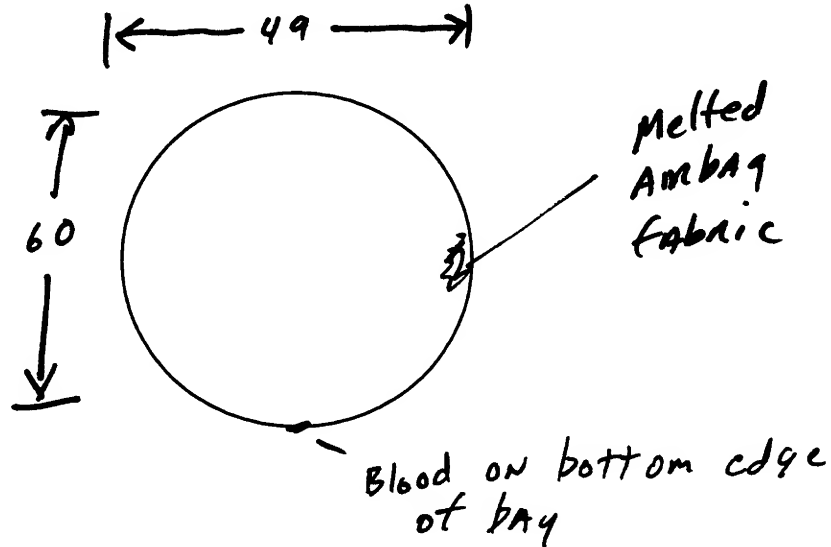
2 vents @ 11 + 1
VF 20.5 W
14 T
LF 19.5 W
8.5 T

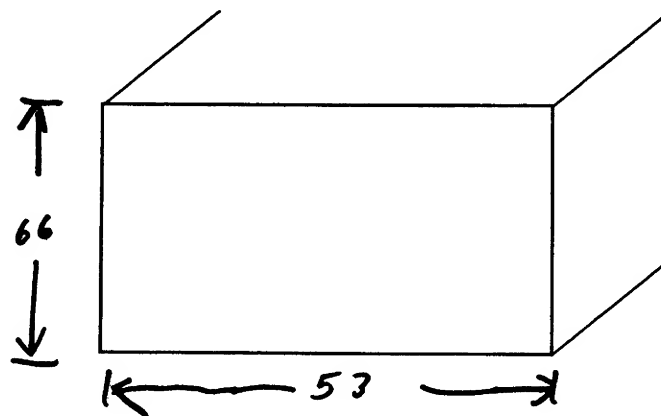
Flap 39.5 W
16.5 T

VENTS @ 3 + 9
ON SIDES

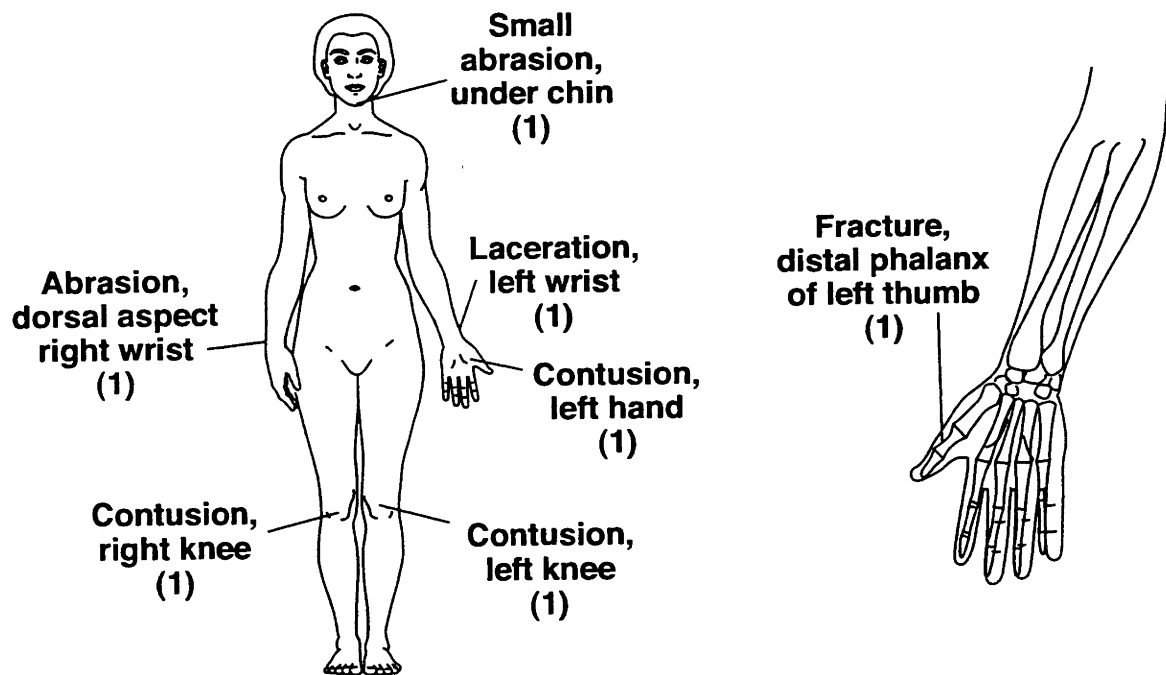
INDICATE LOCATION OF INJURIES.

Injury Description	A.I.S.	Injury Source		
		Definite	Probable	Possible
Small abrasion, under chin	1	Airbag		
Abrasion, dorsal aspect of right wrist	1			Driver's leg/seat cushion (airbag fling)
Laceration, left wrist	1	Watchband/airbag		
Fracture, distal phalanx of left thumb	1		Windshield header/windshield (airbag fling)	
Contusion, left hand	1		Windshield header/windshield (airbag fling)	
Contusion, right knee	1	Knee bolster		
Contusion, left knee	1	Fuse panel		
<u>Maximum A.I.S. Level</u>	<u>1</u>			
<u>Injury Severity Score</u>	<u>2</u>
